May 11, 2026
26-0906

**Re: Emergency Flooding Review of 2nd Concession Road Bridge
(Bridge #2) & 20th Side Road Bridge (Bridge #3)**

2nd Concession Road Bridge (Bridge No. 2) Photographs

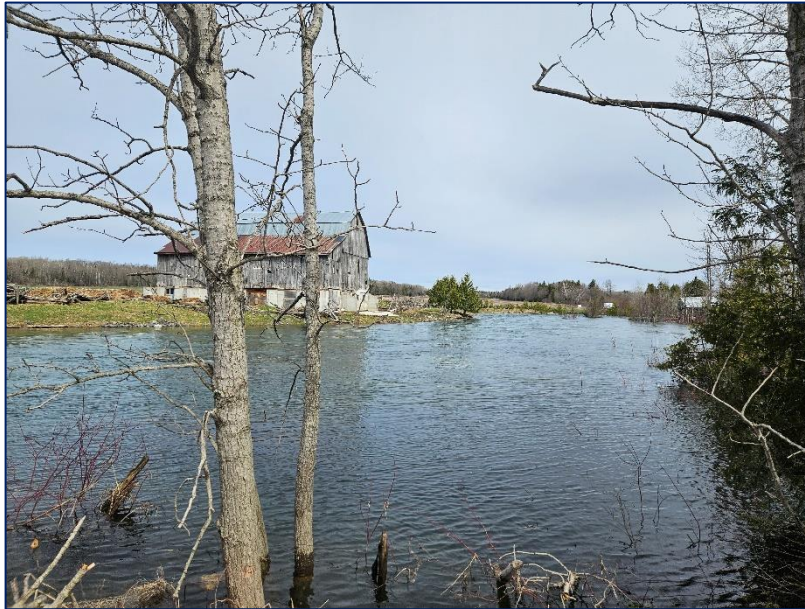
Photograph 1: Looking north upstream of the bridge site. Water backwater is pushing up into the trees along the roadway.

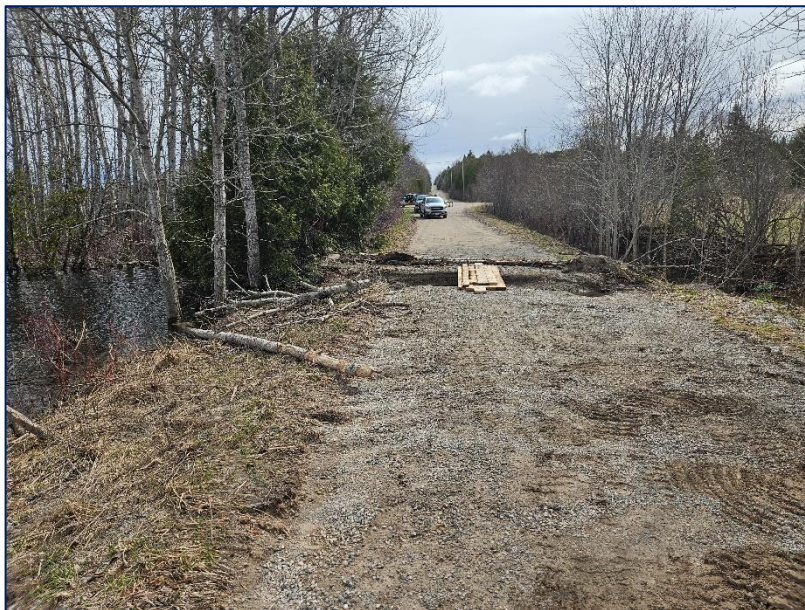
2. There was evidence that the water had overtopped the bridge deck elevation, based on flow patterns in the gravel across the bridge deck.
3. There was a relief channel dug out in the east approach to the bridge. The water level has subsided since the relief channel was cut in the roadway and no water was passing through the relief channel in the roadway.

Photograph 2: Looking east along roadway towards the intersection of 2nd Concession Road and the 20th Side Road. Wood debris on the roadway, and gravel displacement indicating water had over topped the roadway. Relief channel cut into the roadway by the Township still in place.

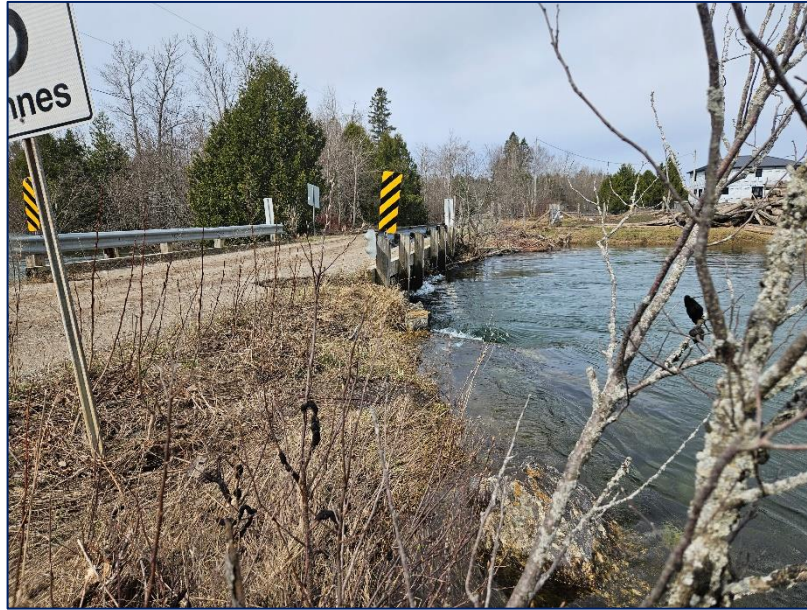
1. The water level was extremely high at the time of the inspection. The water level was touching the underside of the bridge beams and had very high velocities. The velocities were creating white water ripples at the outlet of the bridge heading south.

4. There are significant washouts at both corners of the bridge at the east abutment. The washouts measured approximately 1.2m x 1.2m x 0.69m deep. The wooden ballast walls have been damaged and were partially intact. The loss of the ballast walls from the end of the bridge has further allowed the gravel material to be pulled into watercourse, especially when the velocities of the water being so high.

Photograph 3: North elevation – water level was up to the underside of the bridge beams. Washouts in the north and south quadrants of the east abutment.

Based on the observations made above, this bridge needs to remain closed to traffic until localized steel repairs, new ballast wall and voids in the approaches are repaired. A partial lane shift could be imposed to help alleviate loading onto the beam showing the worst overall conditions. These repairs would be necessary to gain use of this bridge even at emergency levels and those should be limited to small pickup truck/horse and buggy at the largest due to the general steel conditions and inability to review the foundations and pier conditions due to the extremely high-water levels. When water levels allow, any wood debris caught on the bridge/pier should be removed to facilitate maximum flow under the bridge.

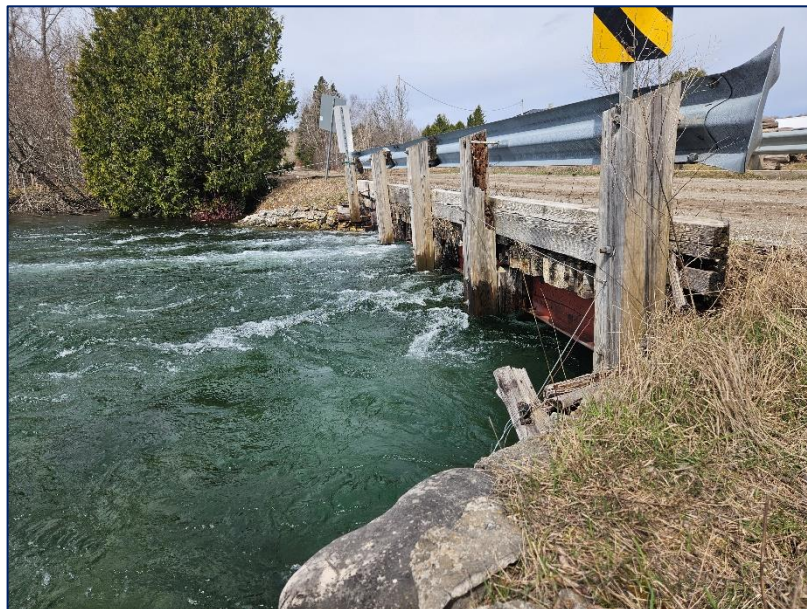
Photograph 4: South elevation – showing high water velocities at downstream end of the bridge.

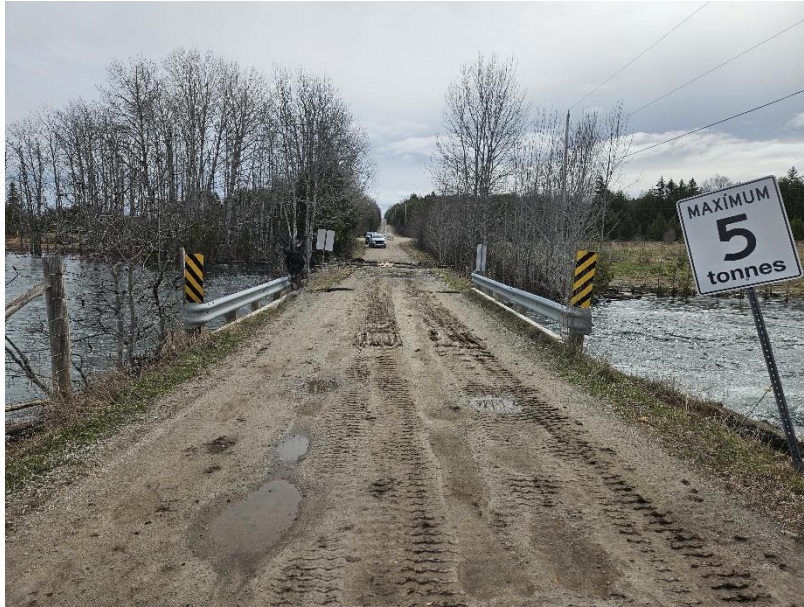
Photograph 5: Looking east across the structure, washouts at the north and south corners of the bridge.

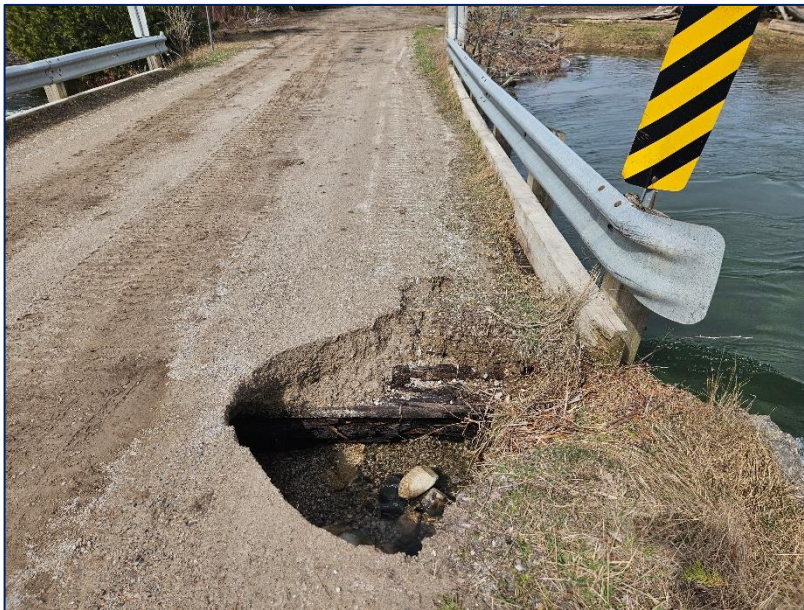
6. The ballast wall at the east end was partially intact and there were areas where the wooden ballast wall was missing. The wood was severely decayed and removed in an area to help further our review of the bridge deck and beam conditions.

Photograph 6: Typical washout at the east end of the bridge. Voids within the gravel backfill and loss of wooden ballast wall at the ends of the steel beams.

- c. Reinstatement of a new ballast wall at the ends of the bridge beams to retain granular materials on the approaches.
- d. The temporary railing along the north edge of the reduced travel lane could be wood in nature and ballasted to sit on top of the bridge deck. This temporary lane shift barrier should not be easily moved or modified.
- e. Repairs to the south railing system would need to be completed. Replace all severely decayed or missing railing posts and re-attach the steel flex beam.
- f. The bridge would need to have additional signage installed to reduce the speed limit to 10km/hr and further reduce the load limit to 3 tonnes.

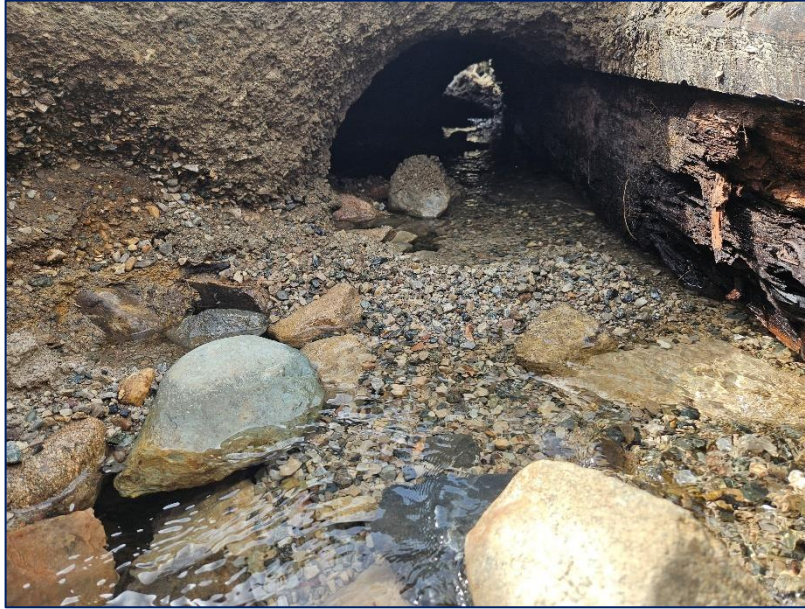
5. A full-length cavity behind the ballast wall across the roadway width at the east abutment was observed. Soil arching was the only thing preventing a full-width trench from developing along the east end of the bridge deck.

Photograph 7: Looking south along the east abutment/ballast wall at void within the granular backfill. Voids below the wood lagging exist

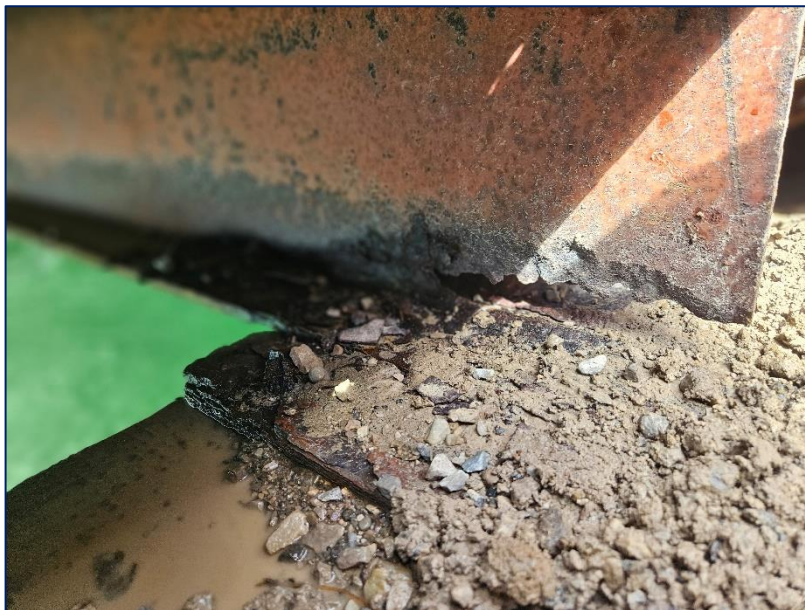
7. There were several beams showing severe corrosion, flaking with section loss and some entire loss of the lower web at the bearings.
8. The 3rd beam from the north at the east abutment bearing is deflecting immediately into the span of the bridge. This was the identified beam having the worst conditions from the 2024 OSIM report.

Photograph 8: Severe corrosion and perforation through the lower web at the bearing location on the east abutment. Multiple locations along the east abutment were noted, upon removal of the semi intact ballast wall.

- a. Bearing stiffeners to be installed at the bearing points of all beams
- b. Installing new 'C' channels or sister beams beside the severely deteriorated beam(s).
- c. Partial replacement of the bridge deck would allow better access for any steel repairs and provide a longer extended service life of the bridge. Including the repairs/replacement of the bridge guiderail systems.
- d. Repairs to the stone wall abutments and center pier. This would include forming and pouring replacement concrete/grout to fix any voids or missing points of the stone walls.

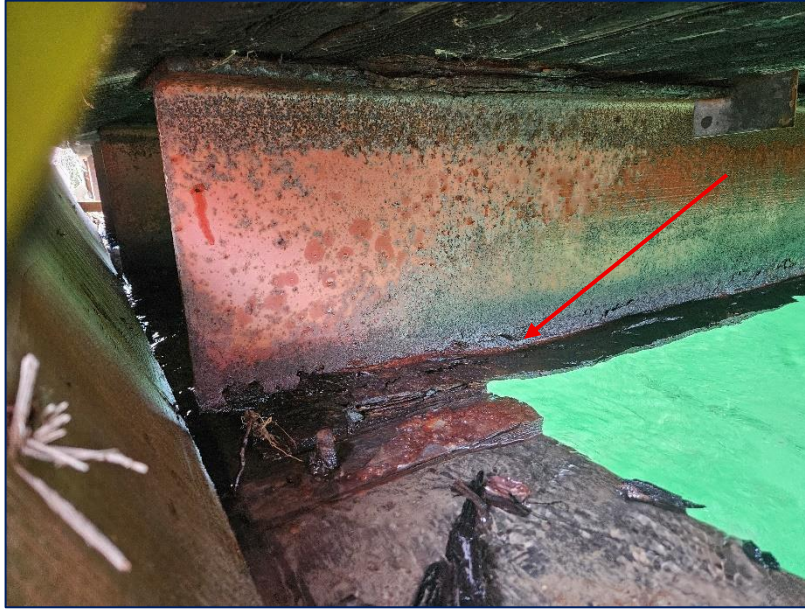
Photograph 9: 3rd Beam from the North at the East Abutment. Very poor condition, with severe corrosion and major section loss of flanges and lower web.

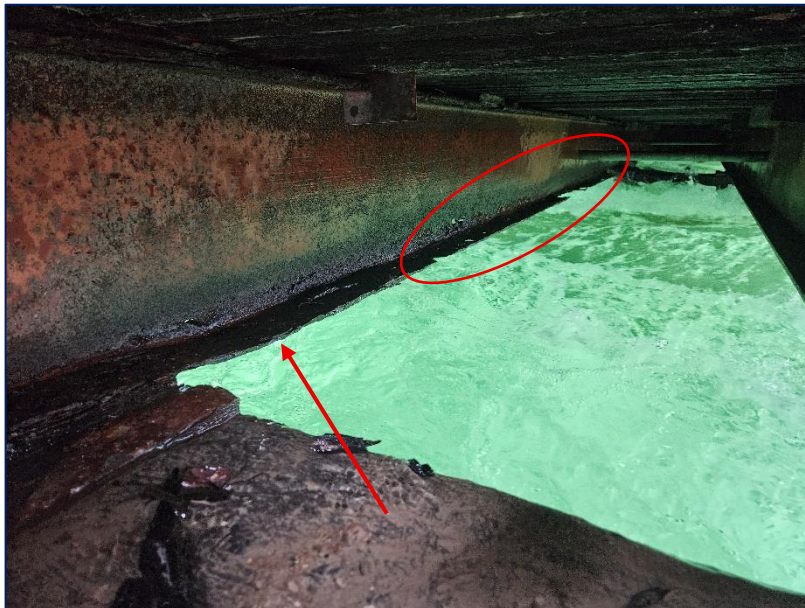
Photograph 10: 3rd Beam from the North at the East Abutment. Very poor condition with deflection of the bottom beam flange at the abutment and large section loss of flanges out at midspan.

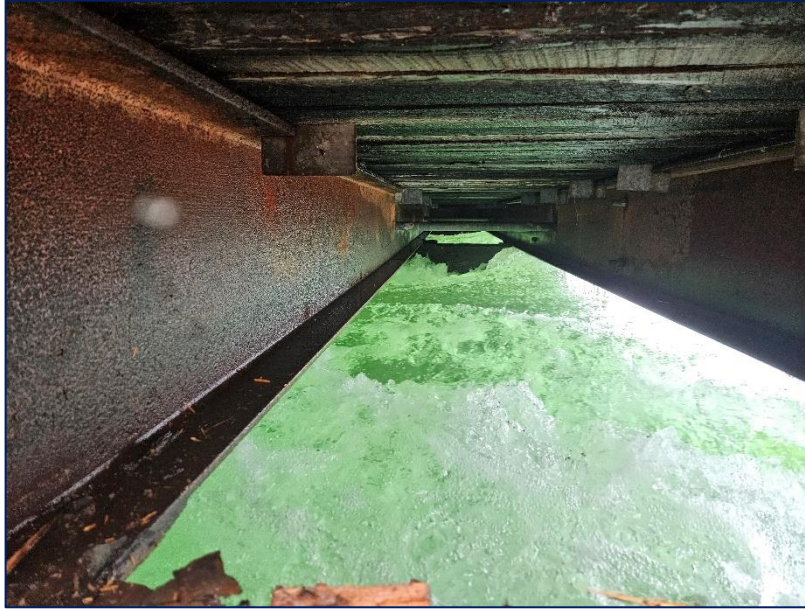
Photograph 11: Looking west at the central pier between the 1st and 2nd beams from the north edge of the bridge at the east abutment.

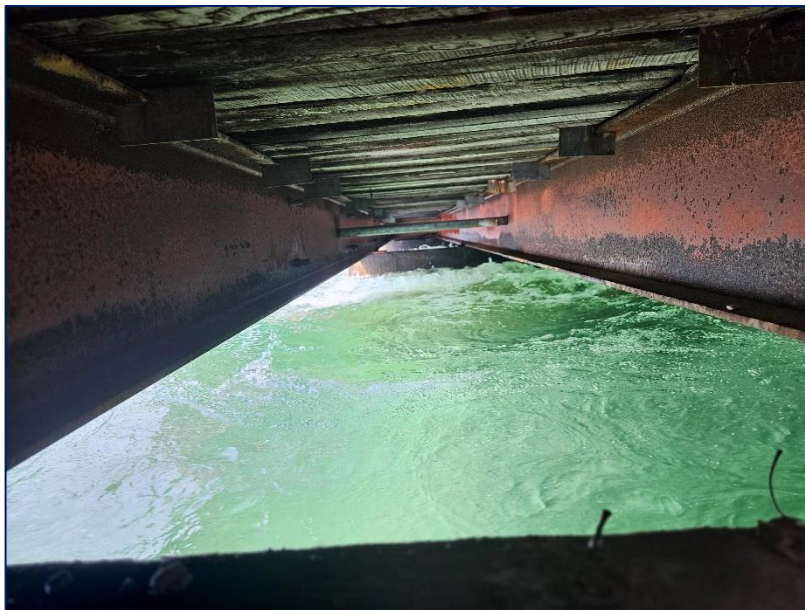
Photograph 12: Looking west from the east abutment along the south exterior beam at the central pier. Steel bracing rods and deck clips are intact.

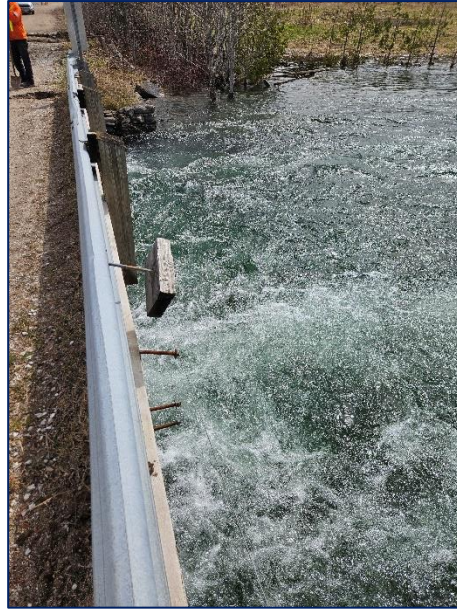
Photograph 13: Missing Guiderail Post on the south Railing system.

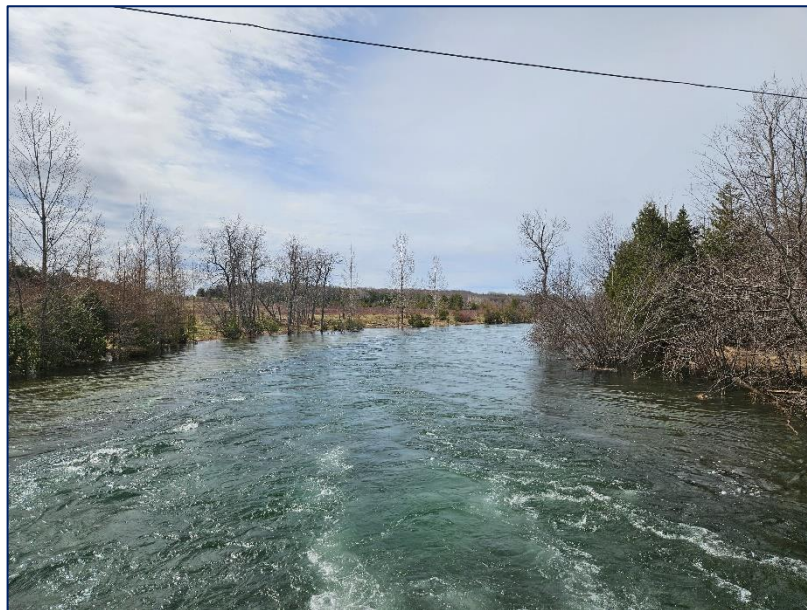
Photograph 14: Looking downstream of bridge site. Water levels have exceeded the normal channel/banks and are pushing into the bush lines along the river.

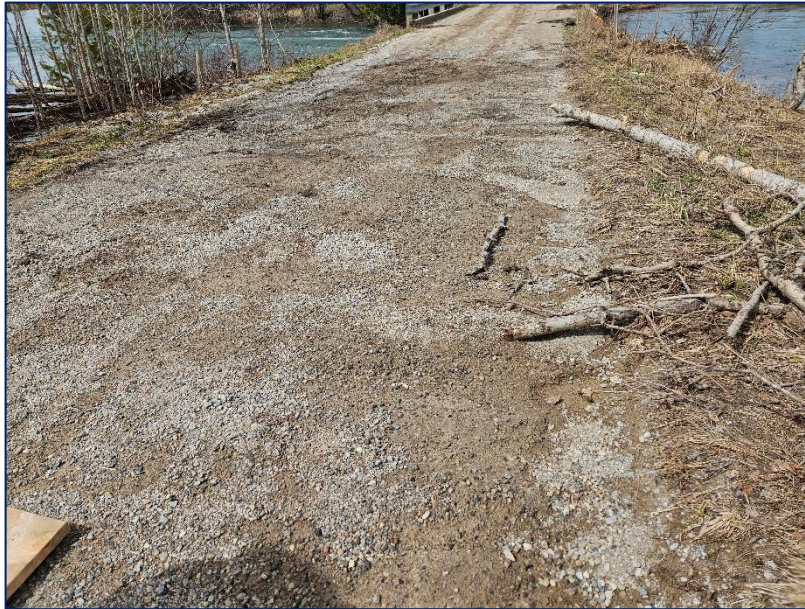
1. The Township had road closed signs and barricades installed at the intersection of 20th Side Road and the 2nd Concession Road.
2. The water had over topped the roadway and submerged the bridge. There was evidence that supported there was once flowing water over the bridge deck and at the south approach by the washing of gravel /debris downstream in a westerly direction. There was wood debris located on the upstream shoulders of the roadway.

Photograph 15: Looking north towards the structure with wood debris along the roadway and gravel disturbances across the roadway indicating the road was once under water.

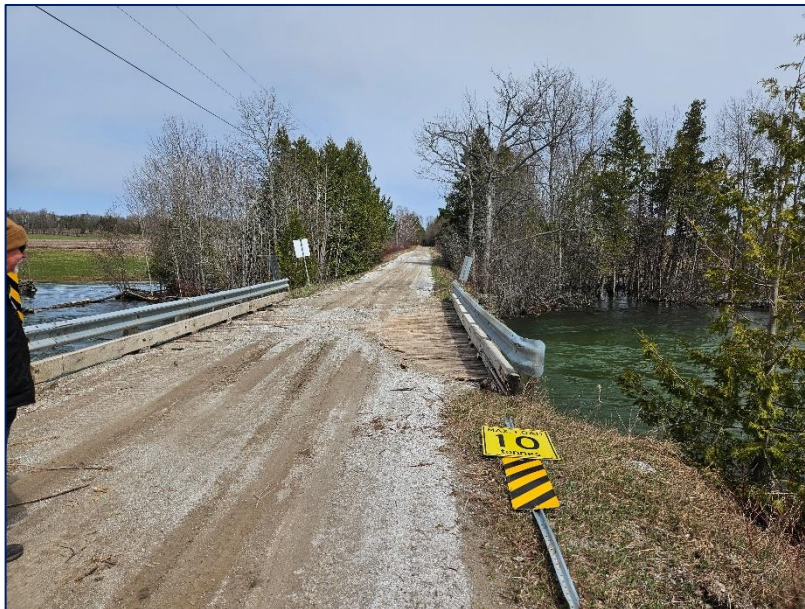
Photograph 16: Looking north across the structure. Gravel on the deck surface has been washed downstream (westerly) indicating extremely high-water levels that overtopped the bridge deck surface.

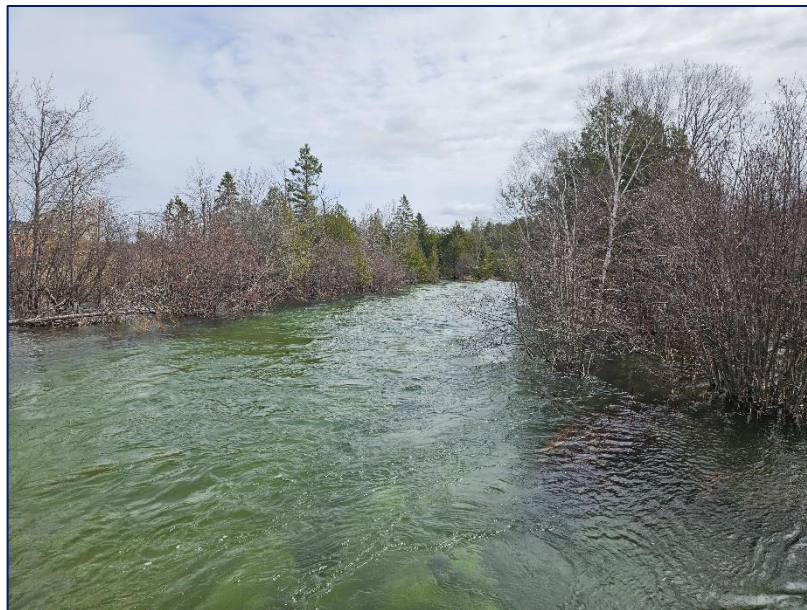
Photograph 18: Looking upstream. Water levels have exceeded the normal channel/banks and are pushing into the bush lines along the river.

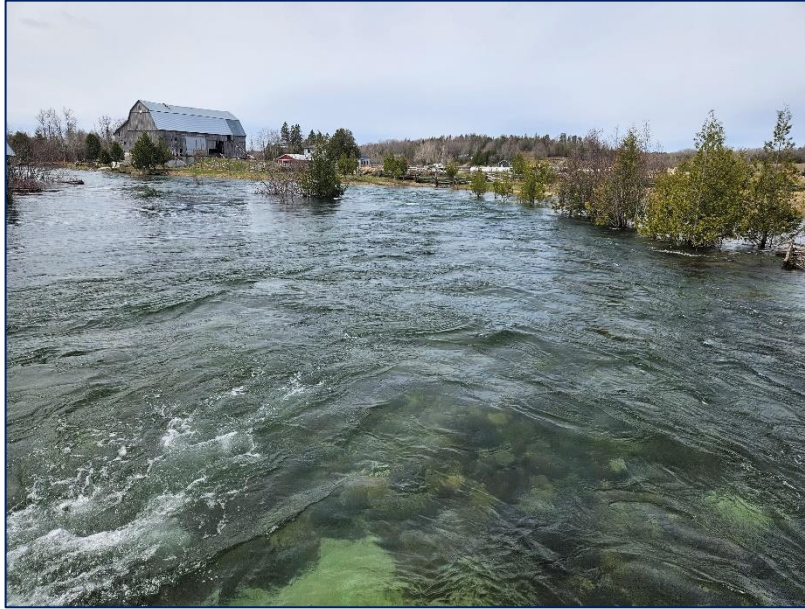
Photograph 19: Looking downstream towards bridge No. 2 (beyond the barn). Water levels have exceeded the normal channel/banks and are pushing into the bush lines along the river.

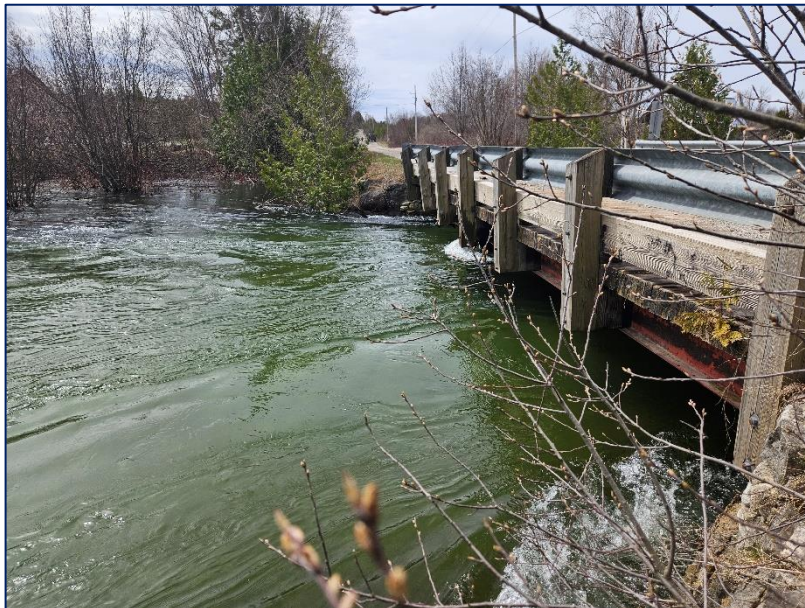
Photograph 20: West elevation with water approximately 16” (400mm) below the underside of the steel beams.

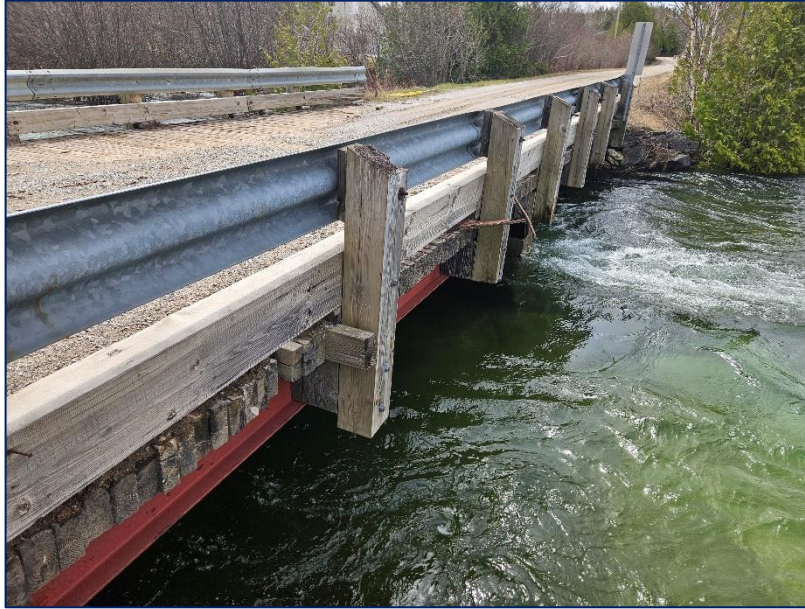
Photograph 21: West elevation with high flow velocities from under the bridge.

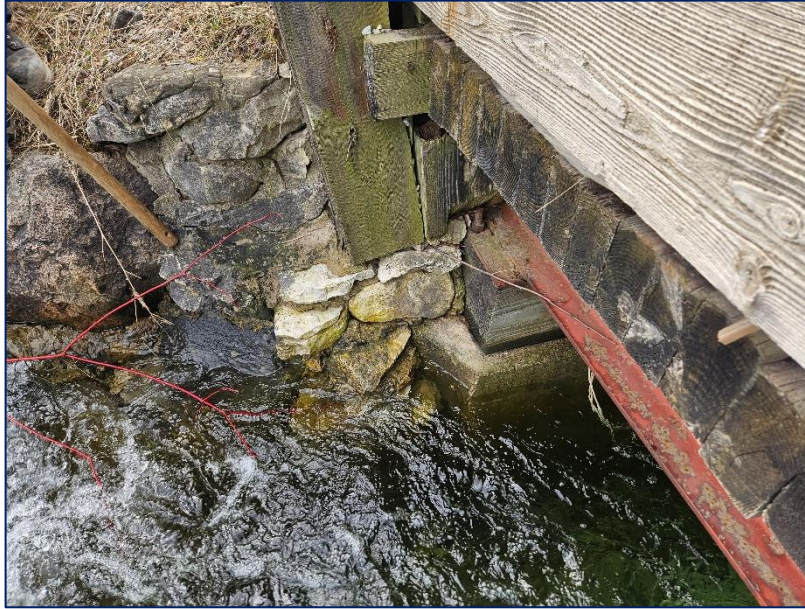
5. The bridge has good bearing at the abutments and the pier.
6. There was debris/wood caught on the upstream nosing of the central pier.
7. There didn't appear to be any lateral movement of the bridge based on the position of the basement plates under the exterior beams and positioning of the bridge at the concrete/stone wingwalls.

Photograph 23: View of the south abutment bearing timber and contact at the stone/rock wingwall. No signs of any movement of the bridge relative to the abutments.

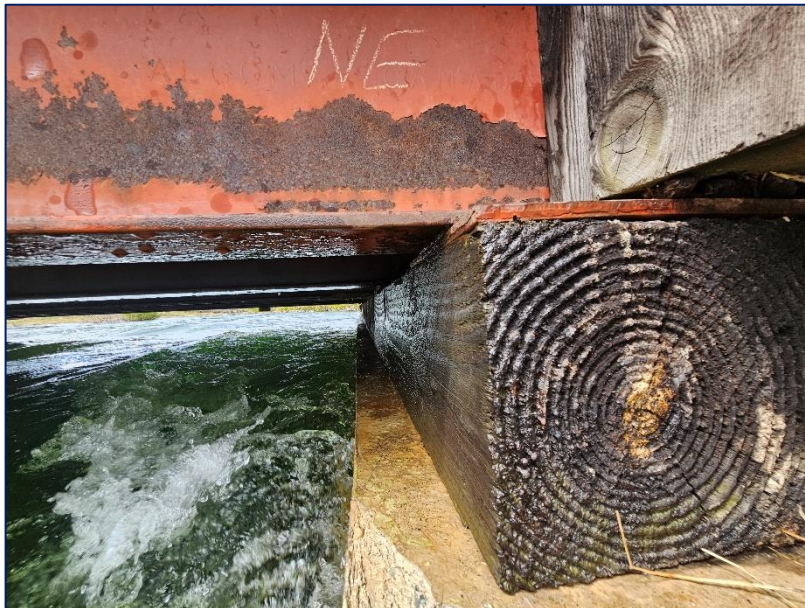
Photograph 24: Looking west along the north abutment at the bearing timber and bearing of the steel beams onto the abutment. Good contact remains with no signs of movements.
